Manhole Inspection Summary

Manhole # S45MM_039MH

Inspection ☐ Is Incomplete Rating: **3) Fair**

Insp Date: **3/25/08 11:10 AM**

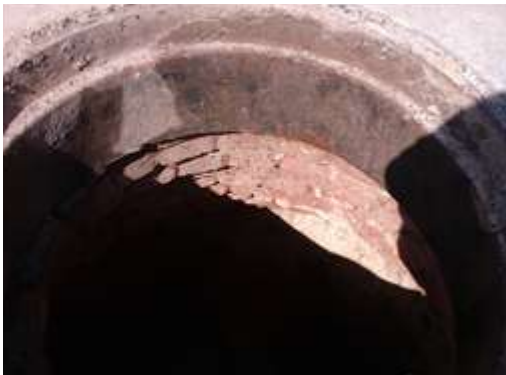
Defect 1

Condition: ☐ Sound ☐ Cracked ☐ Root Intrusion ☒ **Loose Brick** ☐ Deteriorated

Infiltration: ☐ None ☐ Joint ☐ Cracks ☒ **Mortar** ☐ Roots ☒ **Wall**

Adjustment Joint

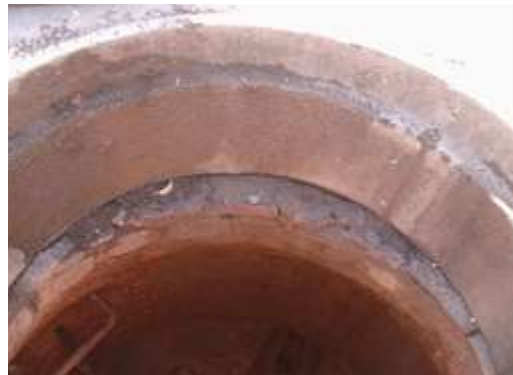
Defect 3

Offset: **2** (in.)

Offset

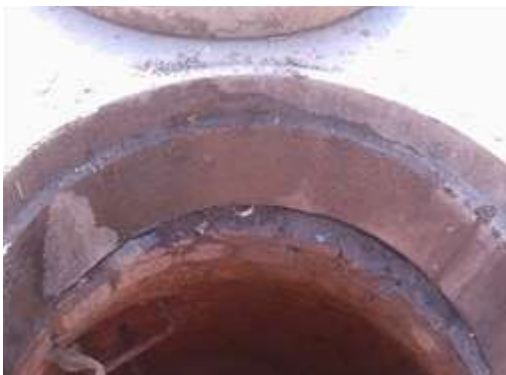
Defect 2

☒ **Leaks**

Frame Leaks

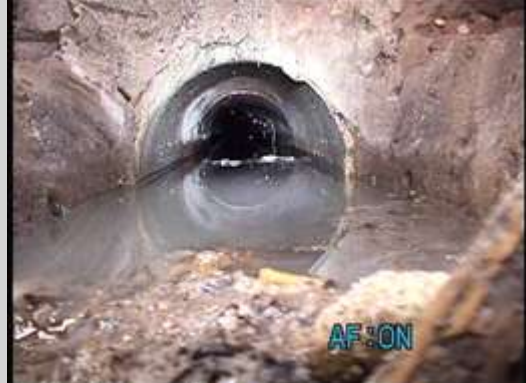
6 O'Clock Inflow

Invert Depth: **6.60** (ft.) Flow Characteristics: **Slow**

Deposits: ☐ None ☒ **Mud** ☒ **Sludge** ☒ **Debris** ☐ Grease

Silt Depth: **4** (in.) Deposits Extent: **Heavy**
